October 12, 2022

RE: Review of Joplin Union Depot Building  
205 N Main Street  
Joplin, Missouri

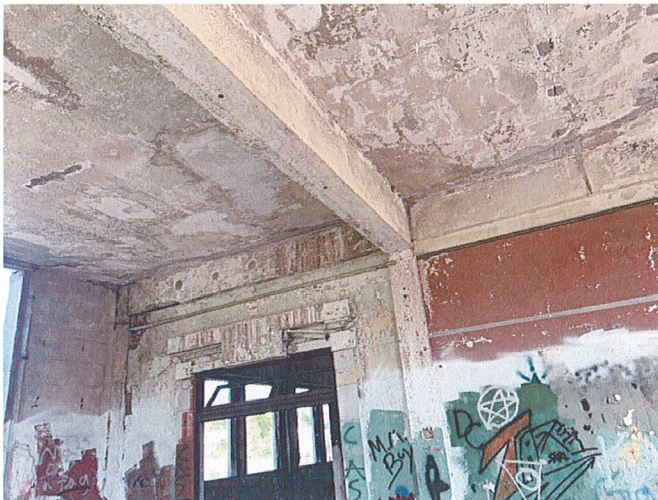
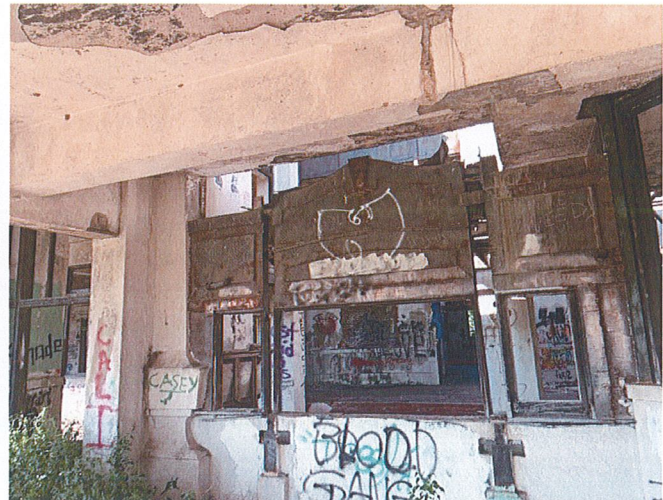
This building has a floor area of approximately 23,816 SF with approximately 18,216 SF at the first level and a center second level of 5,600 SF. Unlike other older reinforced concrete structures, this building did utilize longer spans with deeper girders than you would typically find with other buildings of this era which does allow a good degree of flexibility for rehabilitation of this structure. The follow pictures depict some of the deeper beams in this structure:

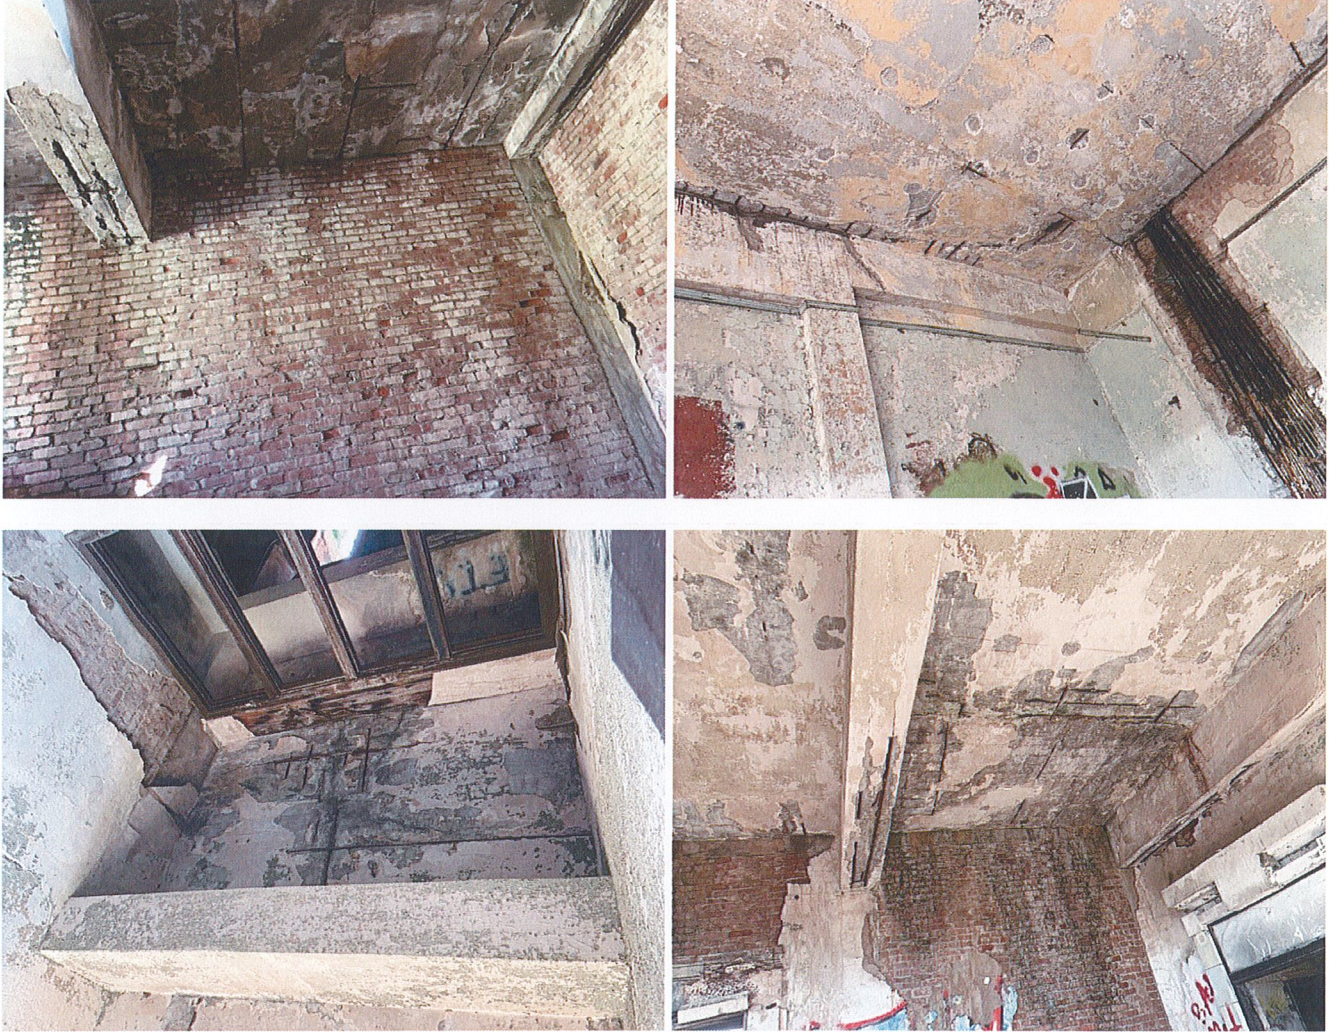
Although there is presently a significant level of graffiti and paint on this structure, this damage is superficial and this concrete can be restored to its original look. At some areas of this building, some initial steel corrosion deterioration was observed as shown in the following pictures:

Because this building's use did not expose the structure to a high degree of chlorides over time, the level of corrosion is quite limited and minor in nature. Its repair would consist of the cleaning of corroded reinforcing steel and patching the concrete. This is a fairly commonplace repair with reinforced concrete structures of this age.

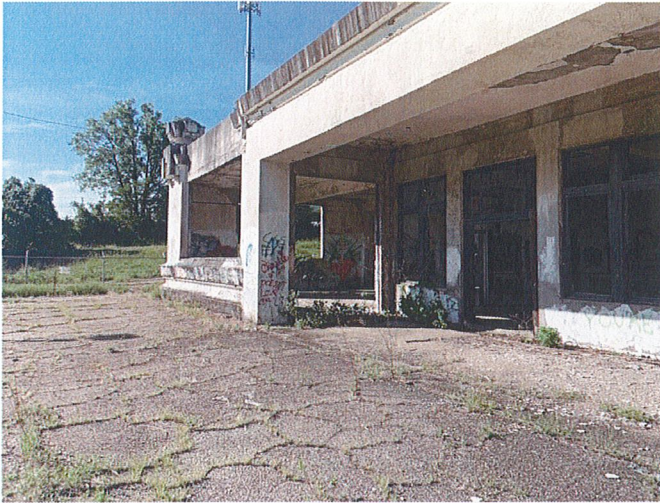
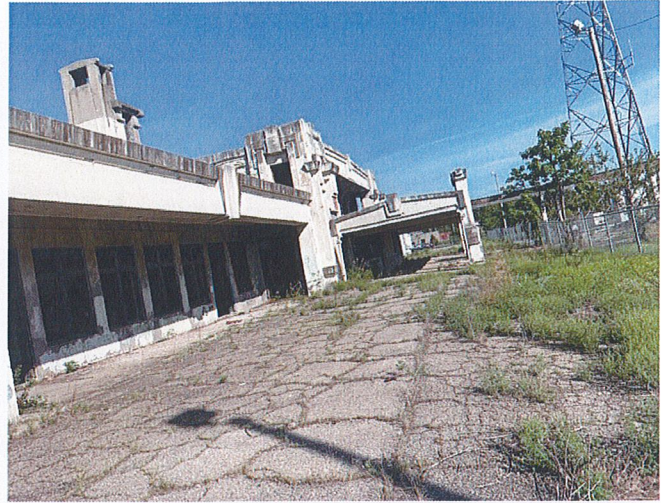
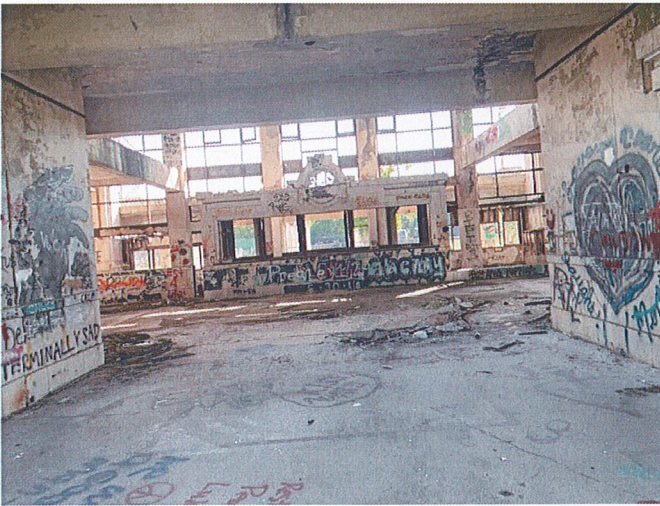
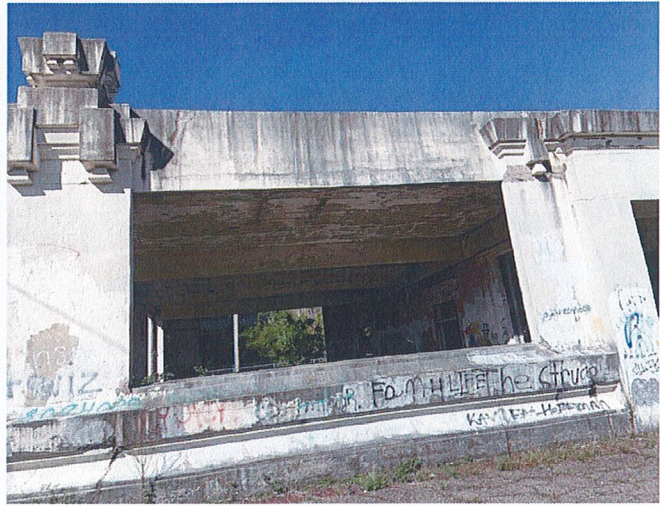
Although the load carrying capabilities of this structure will require some degree of future load testing and evaluation, our past experience would indicate that the second floor and roof level have significant live-load capacities available based upon their long service life and visual observation of their structure members to be square and plumb with minimal signs of any distress to this concrete frame observed. The following pictures depict some of these areas:
