**PHASE I ENVIRONMENTAL  
SITE ASSESSMENT**

**Joplin Union Depot  
207 North Main Street  
Joplin, Missouri**

**BE&K/Terranext Project No. 17102191**

**April 25, 2001**

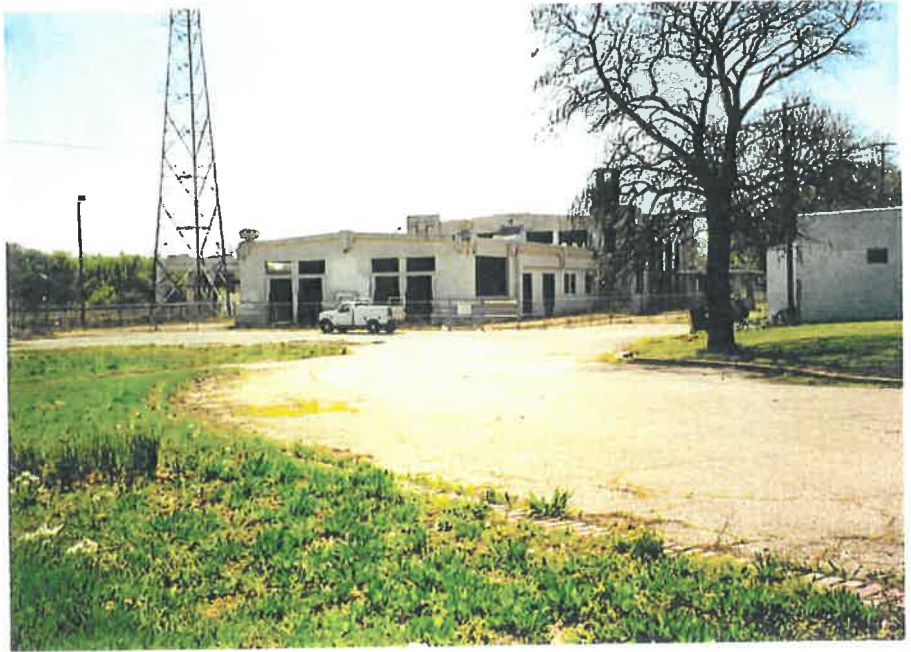
**Project No.:** 17102191  
**Project:** Joplin Union Depot  
**Photograph No.:** 1  
**Photographer:** ESC  
**Date:** 04/13/01  
**Direction:** Southeast  
**Description:** View of subject property from northwest corner of drive entrance.

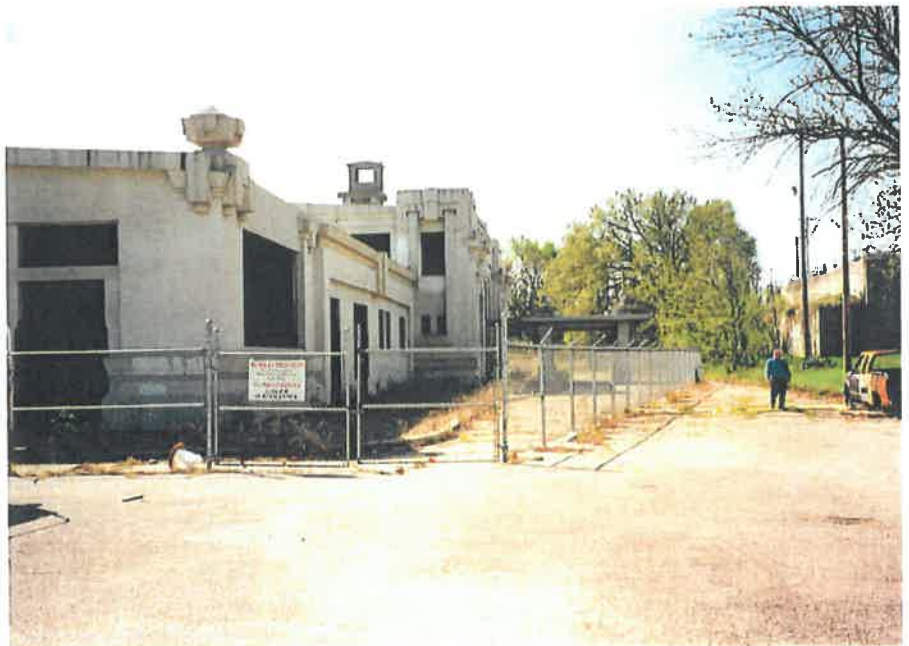
**Project No.:** 17102191  
**Project:** Joplin Union Depot  
**Photograph No.:** 2  
**Photographer:** ESC  
**Date:** 04/13/01  
**Direction:** South  
**Description:** View of west elevation from northwest corner.

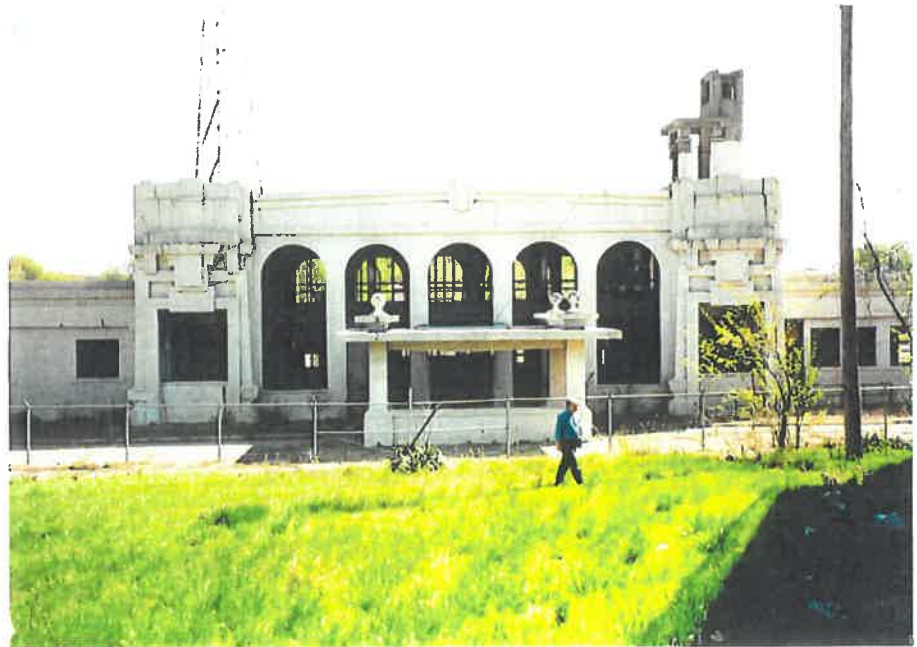
**Project No.:** 17102191  
**Project:** Joplin Union Depot  
**Photograph No.:** 3  
**Photographer:** ESC  
**Date:** 04/13/01  
**Direction:** East  
**Description:** View of west elevation from west/central property boundary.

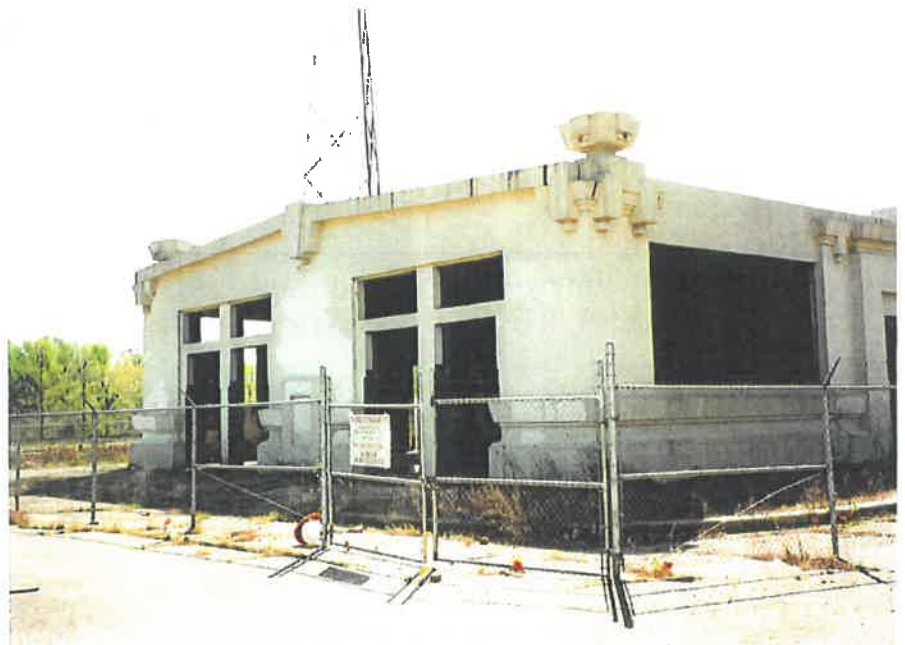
**Project No.:** 17102191  
**Project:** Joplin Union Depot  
**Photograph No.:** 4  
**Photographer:** ESC  
**Date:** 04/13/01  
**Direction:** Southeast  
**Description:** View of south elevation.

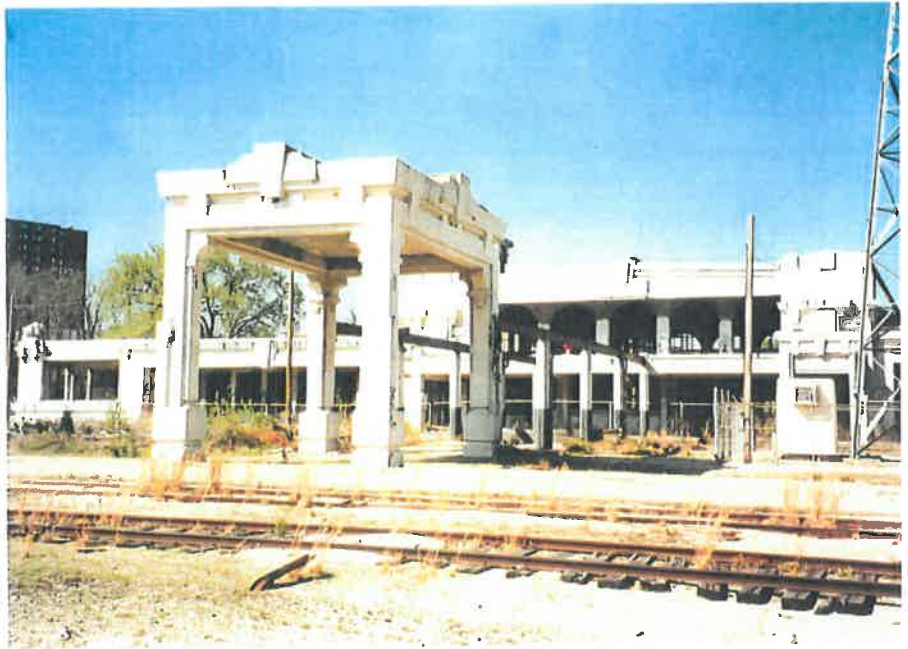
**Project No.:** 17102191  
**Project:** Joplin Union Depot  
**Photograph No.:** 5  
**Photographer:** ESC  
**Date:** 04/13/01  
**Direction:** Southwest  
**Description:** East end of structure, as viewed from neighboring property adjacent to east/central portion of subject property.

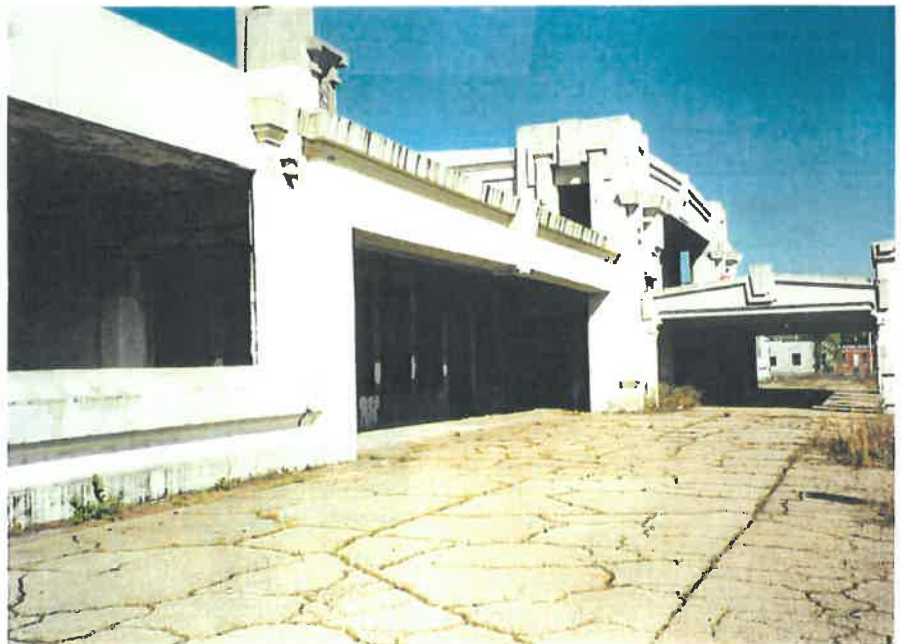
**Project No.:** 17102191  
**Project:** Joplin Union Depot  
**Photograph No.:** 6  
**Photographer:** ESC  
**Date:** 04/13/01  
**Direction:** Northwest  
**Description:** View of east elevation.

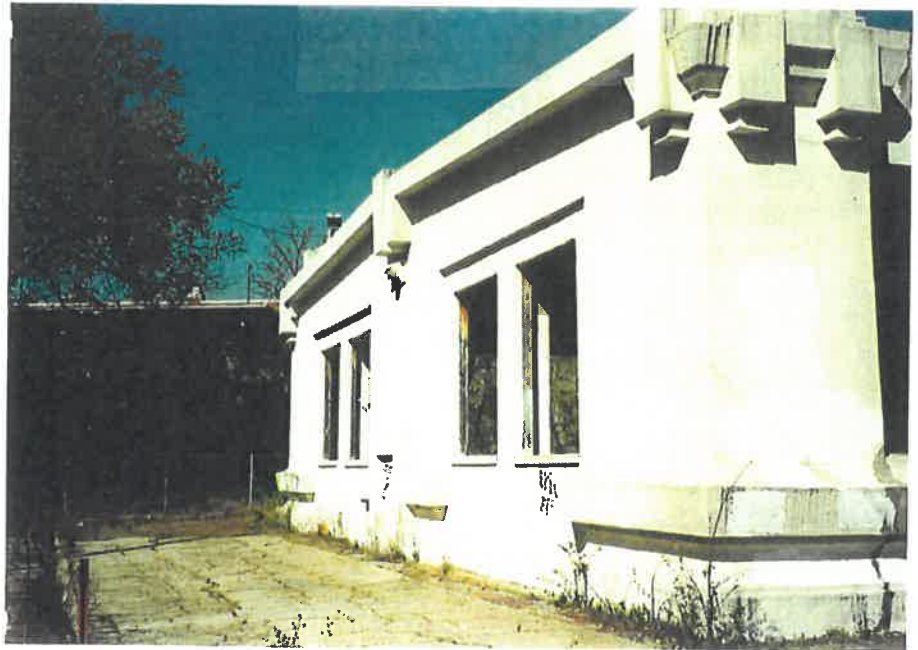
**Project No.:** 17102191  
**Project:** Joplin Union Depot  
**Photograph No.:** 7  
**Photographer:** ESC  
**Date:** 04/13/01  
**Direction:** West  
**Description:** View of south elevation.

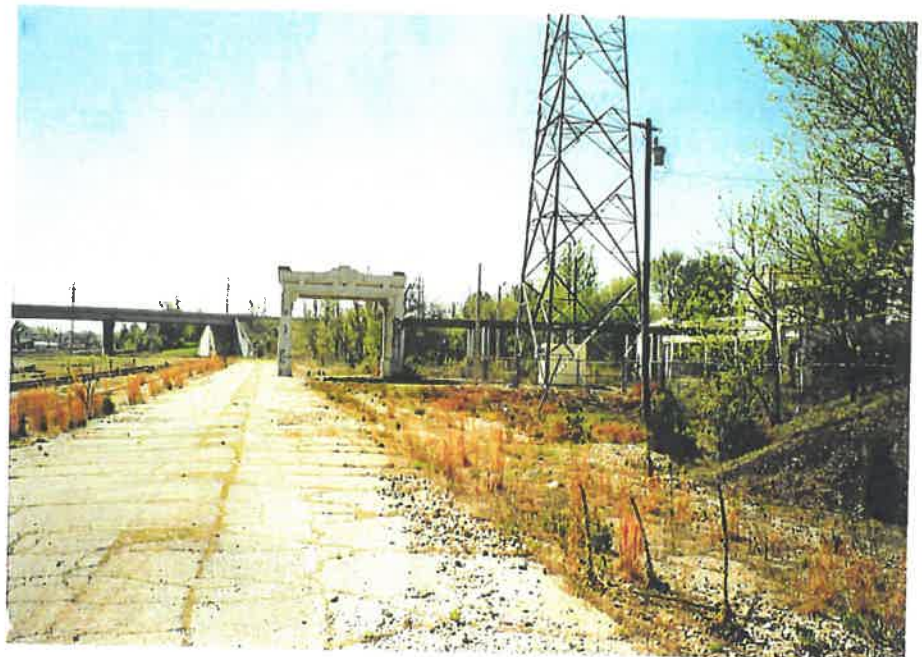
**Project No.:** 17102191  
**Project:** Joplin Union Depot  
**Photograph No.:** 8  
**Photographer:** ESC  
**Date:** 04/13/01  
**Direction:** South  
**Description:** View to south along east property boundary. Property terminates at bridge, visible in background.

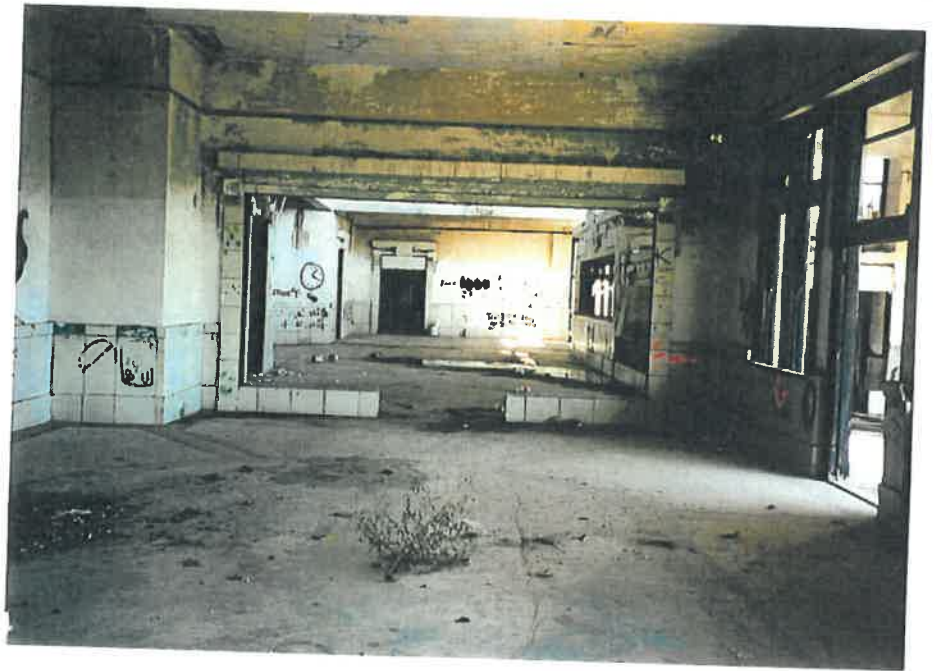
BE&K/Terranext identified suspect lead-based paint (LBP) on the majority of the interior surfaces of the former depot building. At the time of the site inspection, the paint appeared to be in poor condition. All paint in the former depot building is considered suspect LBP until tested or encapsulated.

**Project No.:** 17102191  
**Project:** Joplin Union Depot  
**Photograph No.:** 9  
**Photographer:** ESC  
**Date:** 04/13/01  
**Direction:**  
**Description:** Interior of depot. Note peeling green and yellow paint on walls and ceiling.

- Prior to major renovation of the building, BE&K/Terranext recommends sampling each type of suspect LBP and suspect ACM to verify the composition of these materials. Major renovation activities that would result in the mass removal of LBP and/or ACM are likely to require special handling and disposal methods. Any transformers present on-site that do not have a blue "NON-PCB" sticker attached to it should also be tested by the local electric utility for PCB dielectric fluid content and labeled.

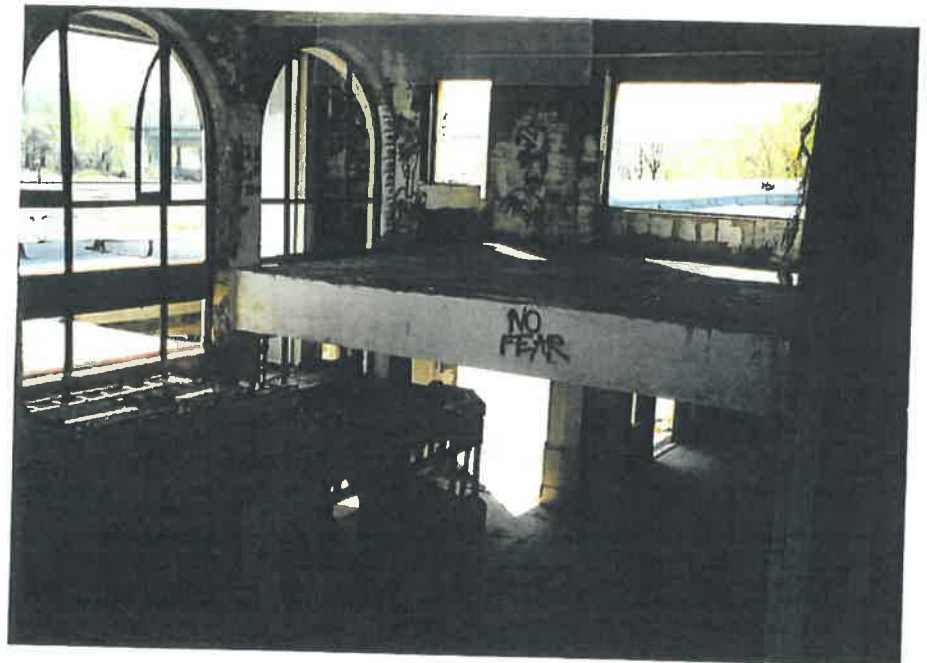
**Project No.:** 17102191  
**Project:** Joplin Union Depot  
**Photograph No.:** 10  
**Photographer:** ESC  
**Date:** 04/13/01  
**Direction:**  
**Description:** Interior of central portion of depot, as viewed from second floor.

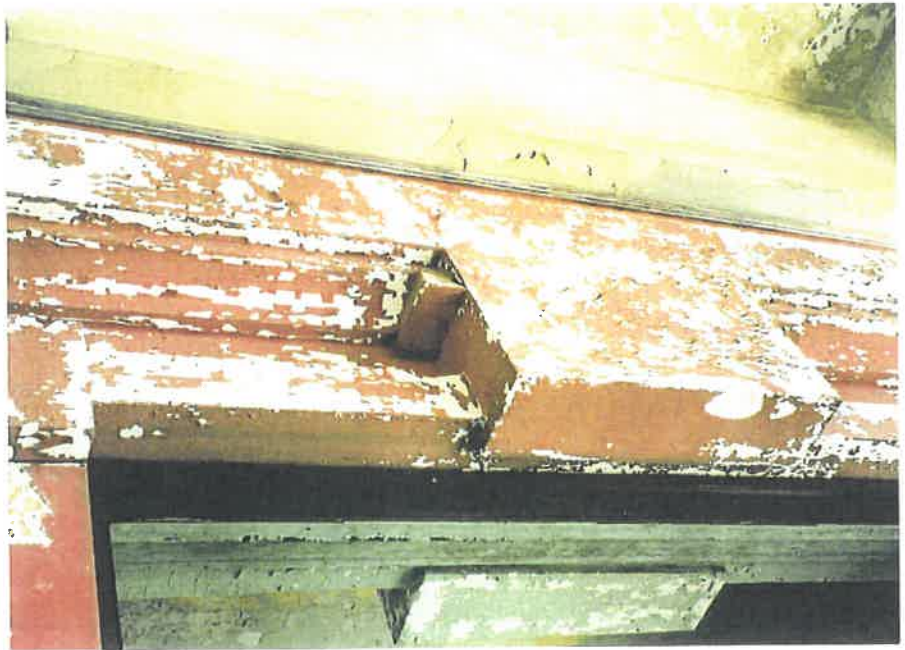
- BE&K/Terranext visually identified suspect LBP in the building located on the subject property. Suspect LBP includes painted walls and ceilings. All suspect LBP was assessed to be in poor condition at the time of the site inspection.

**Project No.:** 17102191  
**Project:** Joplin Union Depot  
**Photograph No.:** 11  
**Photographer:** ESC  
**Date:** 04/13/01  
**Direction:**  
**Description:** Close-up view of peeling, suspect lead-based paint on interior of depot structure.

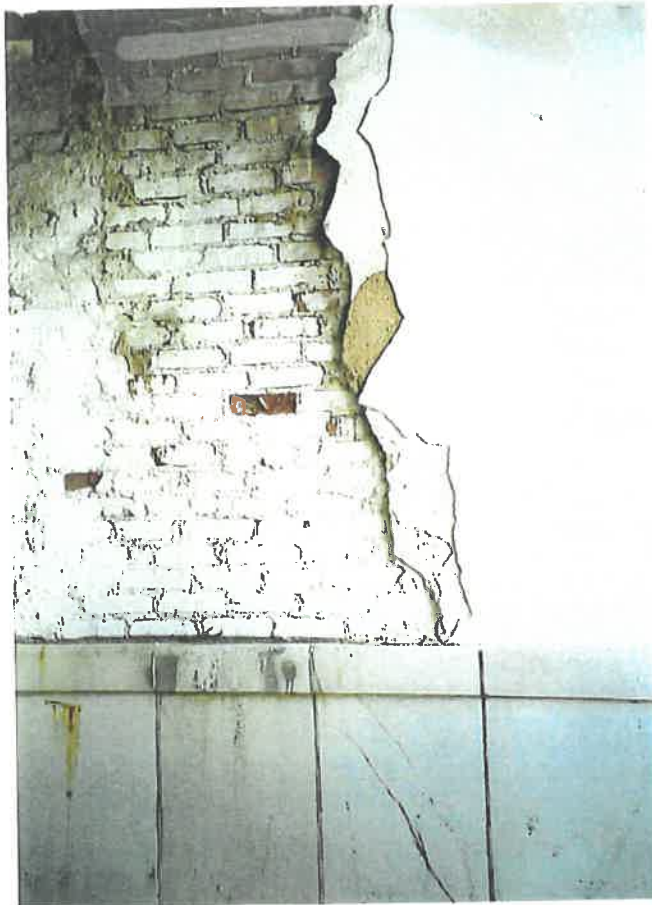
- BE&K/Terranext visually observed suspect ACM in the building located on the subject property. The suspect ACM includes the plaster veneer that covers interior walls. The suspect ACM was assessed to be in fair condition at the time of the site inspection.

**Project No.:** 17102191  
**Project:** Joplin Union Depot  
**Photograph No.:** 12  
**Photographer:** ESC  
**Date:** 04/13/01  
**Direction:**  
**Description:** Close-up view of interior finishing materials.

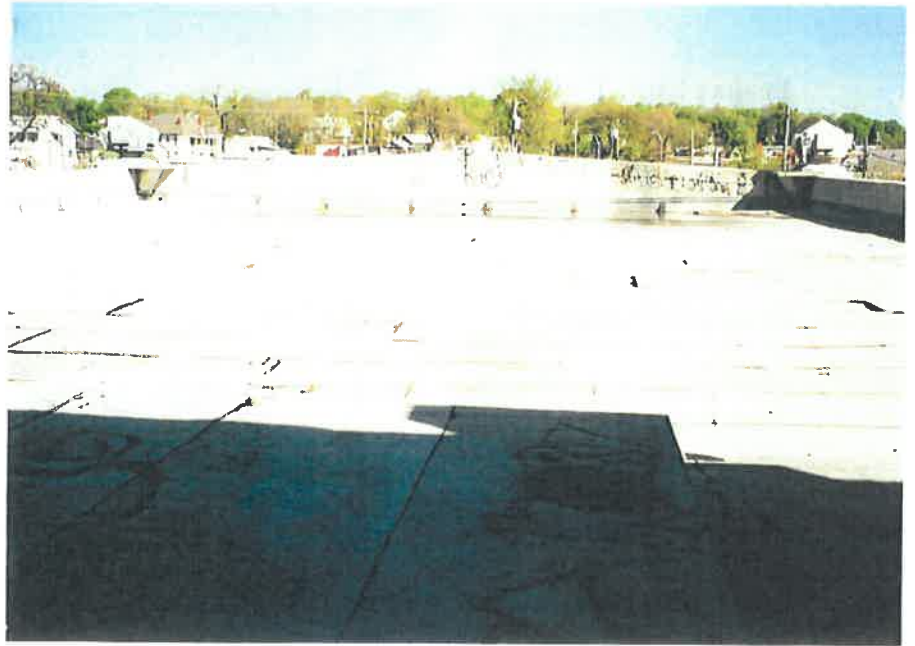
**Project No.:** 17102191  
**Project:** Joplin Union Depot  
**Photograph No.:** 13  
**Photographer:** ESC  
**Date:** 04/13/01  
**Direction:**  
**Description:** Roofing material (typical). Standing water visible in back portion of photo.

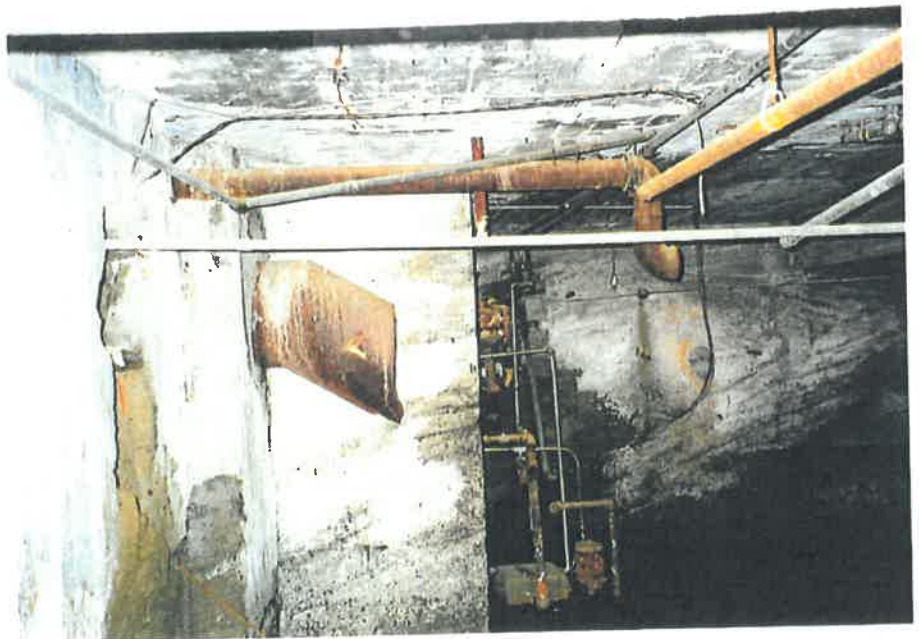
however, the basement of the facility is flooded due to rain and storm water entering the building via broken windows.

**Project No.:** 17102191  
**Project:** Joplin Union Depot  
**Photograph No.:** 14  
**Photographer:** ESC  
**Date:** 04/13/01  
**Direction:**  
**Description:** Remnants of plumbing and heating system in basement.

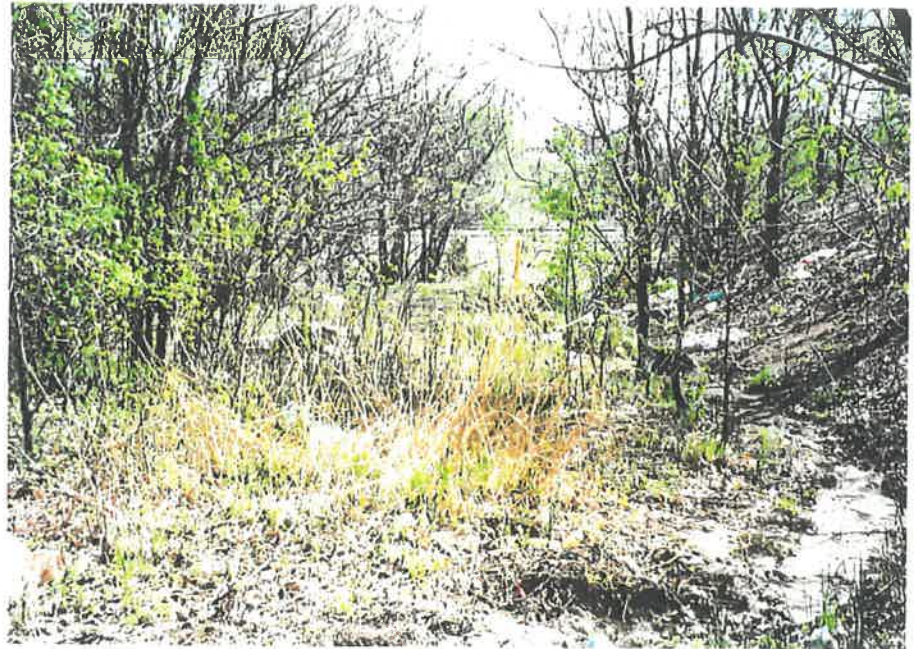
**Project No.:** 17102191  
**Project:** Joplin Union Depot  
**Photograph No.:** 15  
**Photographer:** ESC  
**Date:** 04/13/01  
**Direction:** East  
**Description:** View of south property boundary between subject property and undeveloped adjacent property. Note yellow standpipe in background, designating underground gas transmission line.

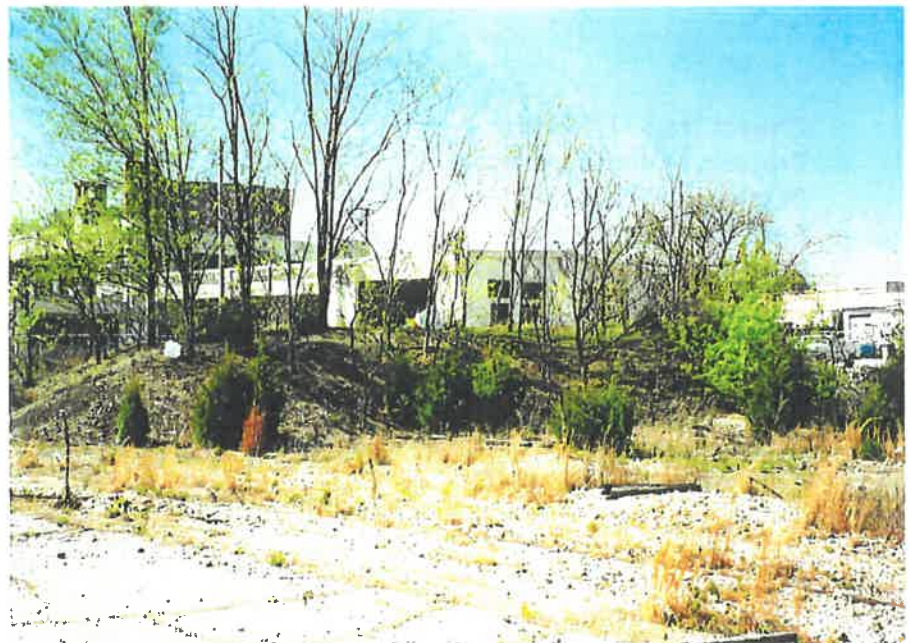
BE&K/Terranext did not identify any foul or unusual odors, pits, wells, or surface impoundments, at the subject property. BE&K/Terranext did not identify any dumping or disposal activities at the subject property. A densely-vegetated pile of soil (approximately 100 square feet in area and 6 feet high) is located north of the building. The source of the soil mound was not evident; however, no indications of buried materials within the mound were observed.

**Project No.:** 17102191  
**Project:** Joplin Union Depot  
**Photograph No.:** 16  
**Photographer:** ESC  
**Date:** 04/13/01  
**Direction:** Southwest  
**Description:** Mounded area located on northeast portion of subject property. Depot visible in background.

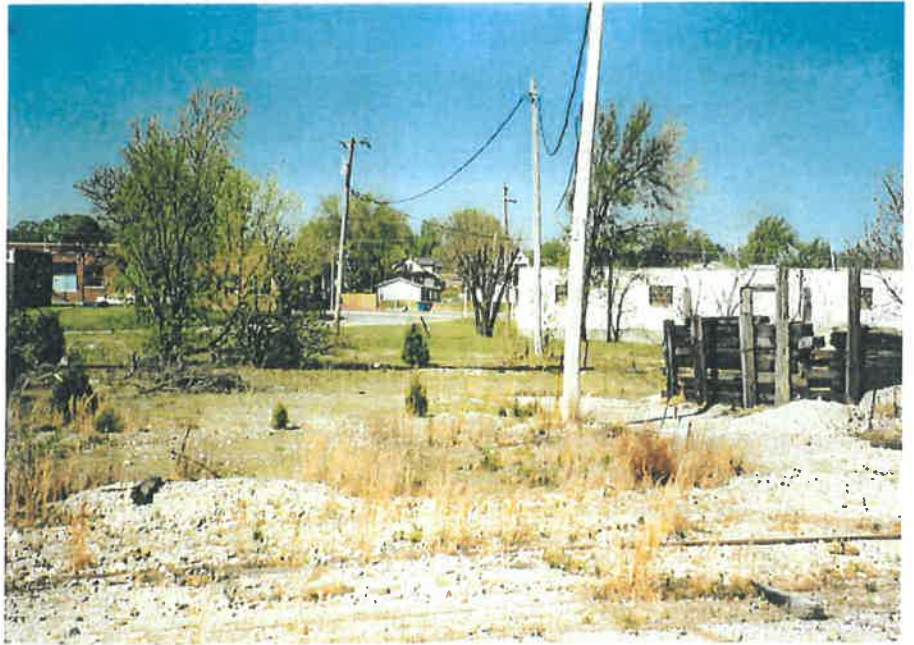
**Project No.:** 17102191  
**Project:** Joplin Union Depot  
**Photograph No.:** 17  
**Photographer:** ESC  
**Date:** 04/13/01  
**Direction:** West  
**Description:** North property boundary, as viewed from northeast corner of subject property.

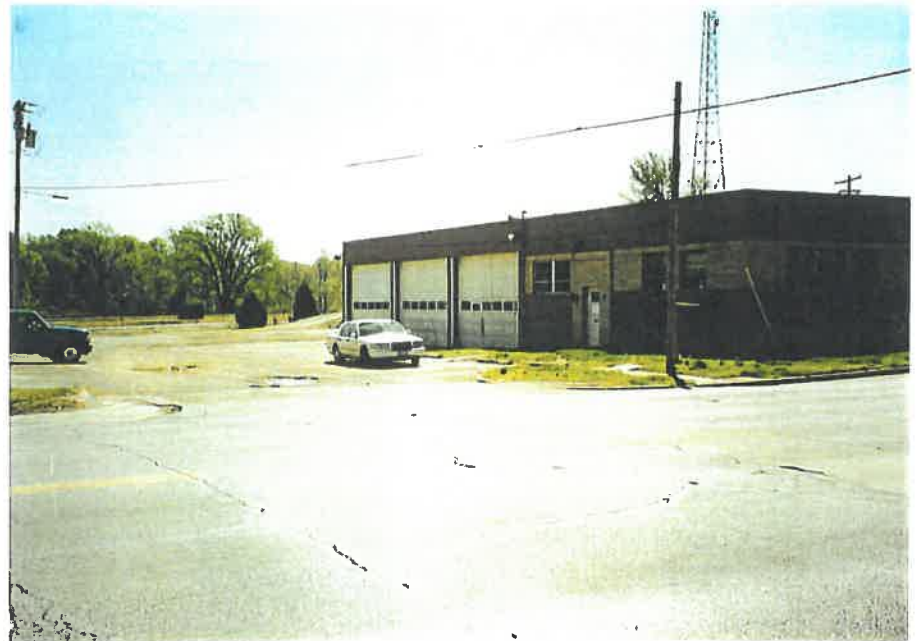
**Project No.:** 17102191  
**Project:** Joplin Union Depot  
**Photograph No.:** 20  
**Photographer:** ESC  
**Date:** 04/13/01  
**Direction:** East/Southeast  
**Description:** View of vacant building located adjacent to north end of subject property.

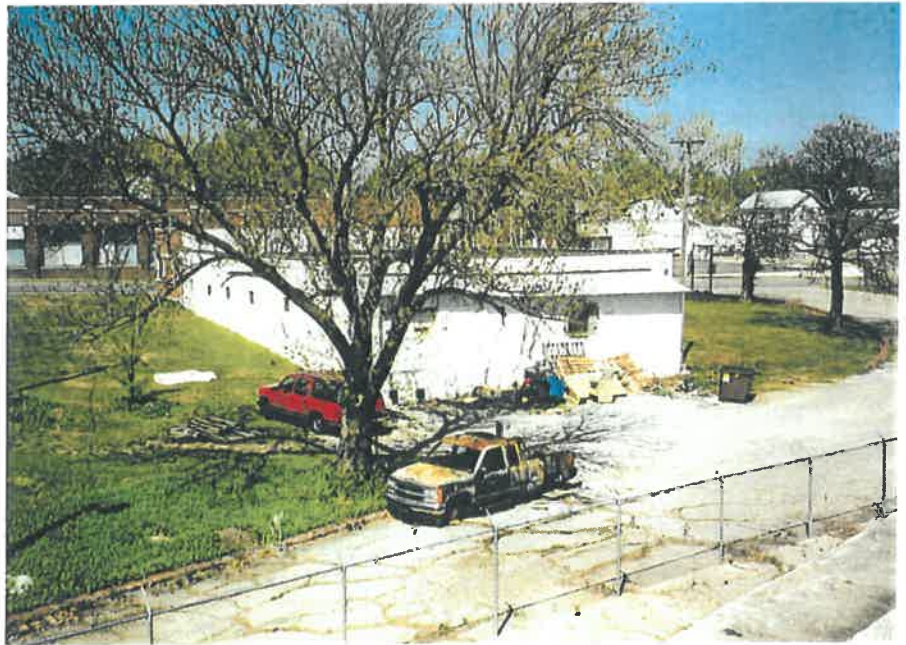
**Project No.:** 17102191  
**Project:** Joplin Union Depot  
**Photograph No.:** 22  
**Photographer:** ESC  
**Date:** 04/13/01  
**Direction:** West  
**Description:** View of 'Commercial Gasket and Packing Company' facility, located adjacent to subject property on the west.

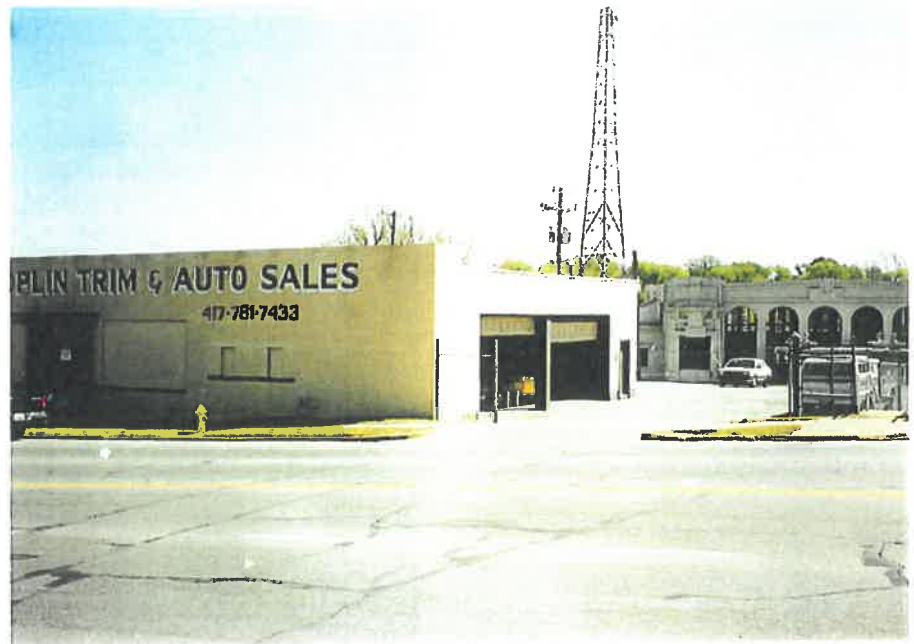
**Project No.:** 17102191  
**Project:** Joplin Union Depot  
**Photograph No.:** 23  
**Photographer:** ESC  
**Date:** 04/13/01  
**Direction:** East  
**Description:** View of auto body shop/sales business located adjacent to subject property on the west. Depot visible in background.

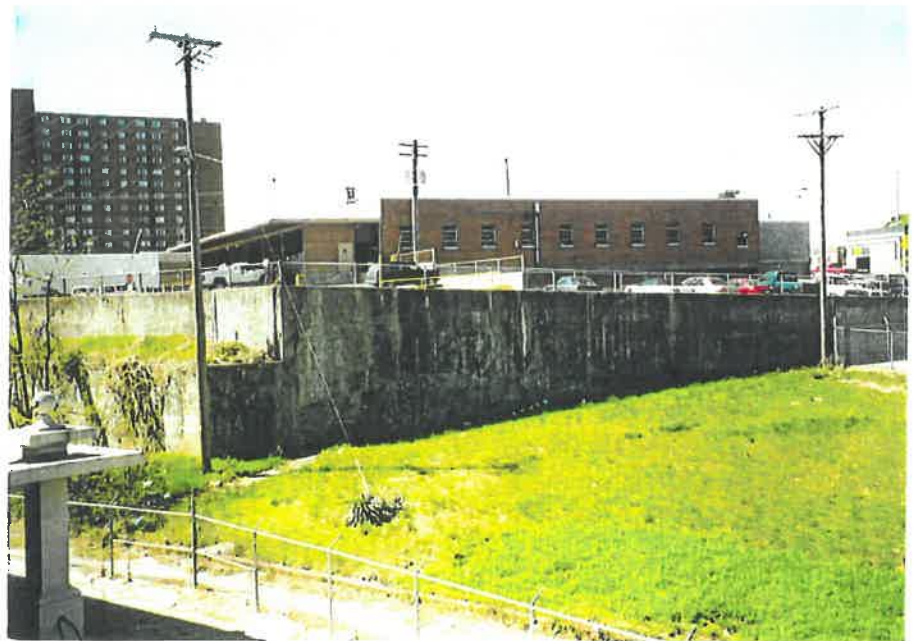
**Project No.:** 17102191  
**Project:** Joplin Union Depot  
**Photograph No.:** 24  
**Photographer:** ESC  
**Date:** 04/13/01  
**Direction:** Southwest  
**Description:** View of USPS building and parking lot from west/central portion of the site.

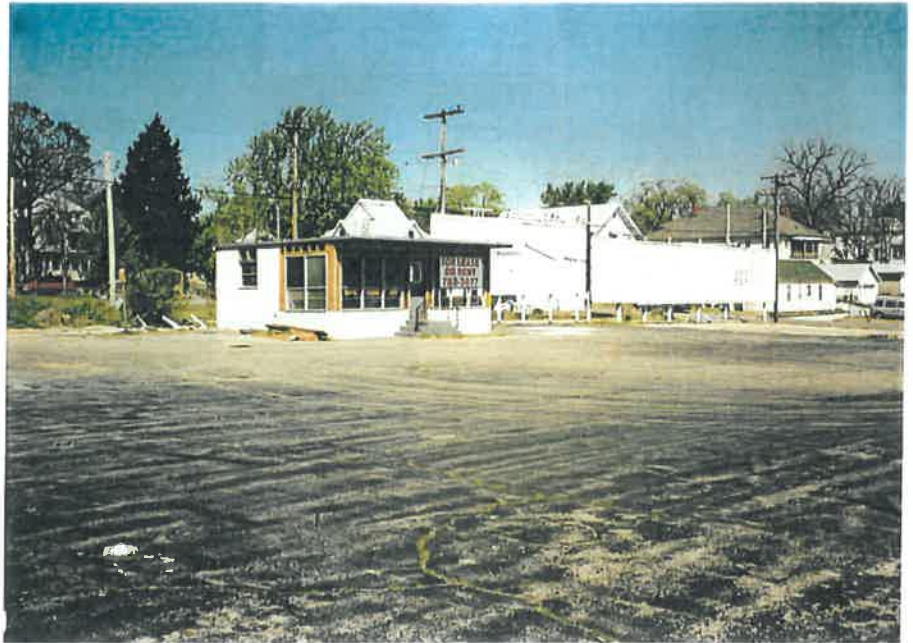
**Project No.:** 17102191  
**Project:** Joplin Union Depot  
**Photograph No.:** 25  
**Photographer:** ESC  
**Date:** 04/13/01  
**Direction:** Northwest  
**Description:** View of former automobile sales lot across Main Street from drive entrance to subject property.

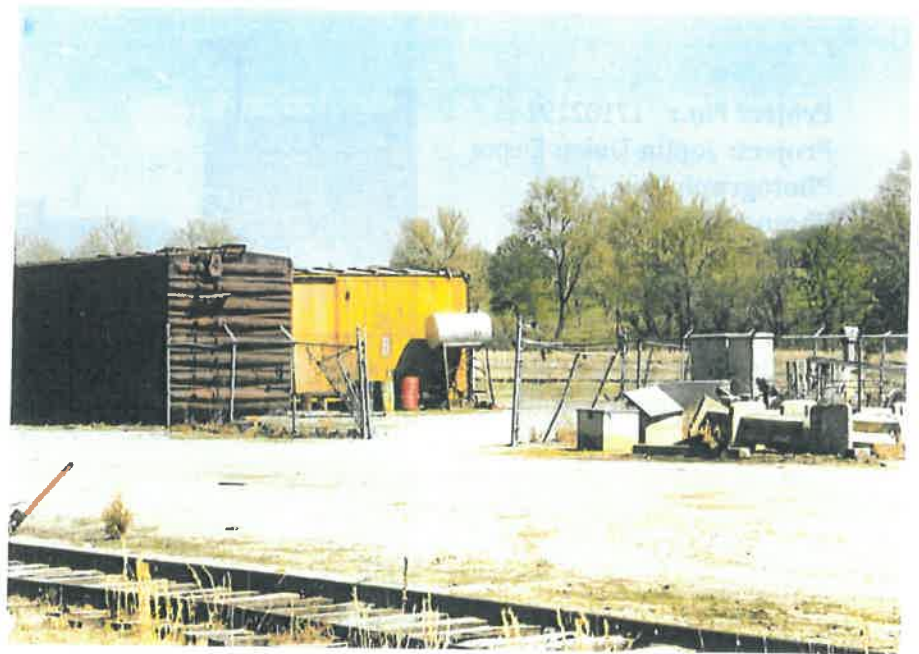
**Project No.:** 17102191  
**Project:** Joplin Union Depot  
**Photograph No.:** 26  
**Photographer:** ESC  
**Date:** 04/13/01  
**Direction:** Northeast  
**Description:** View of AST, and 55-gallon barrels and storage cars adjacent to northeast end of subject property.
